## **Pipeline Group Factual Report**

#### **Stork Draft HA-DM 12" Joints Exam plus Inspection Data**

Report No. 0270-07-17309

Testing and Examination of Pipe from  
Dixie Pipeline Company's  
12-inch Hattiesburg, MS to Demopolis, AL Pipeline

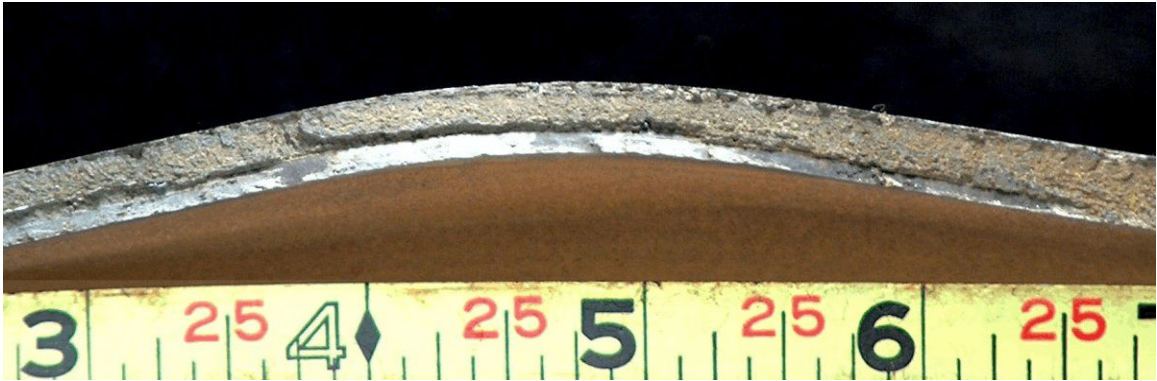
Figure 4

Photograph showing the rupture in Joint No. 6105.

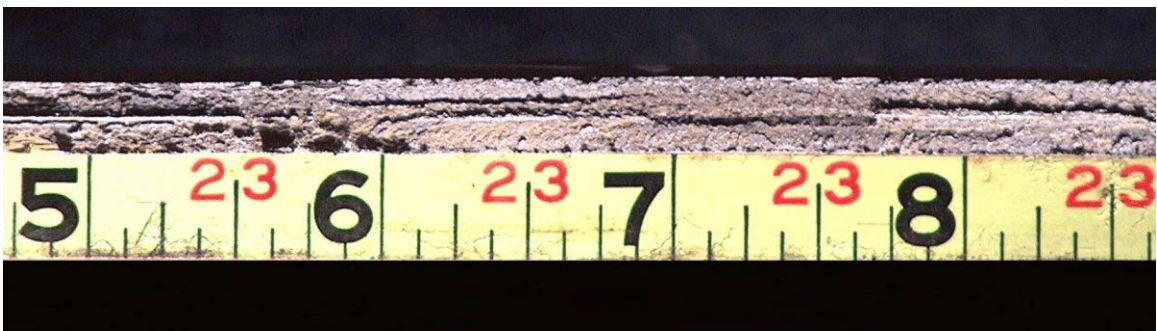
Figure 5

Close-up view of the hook crack at the failure origin.

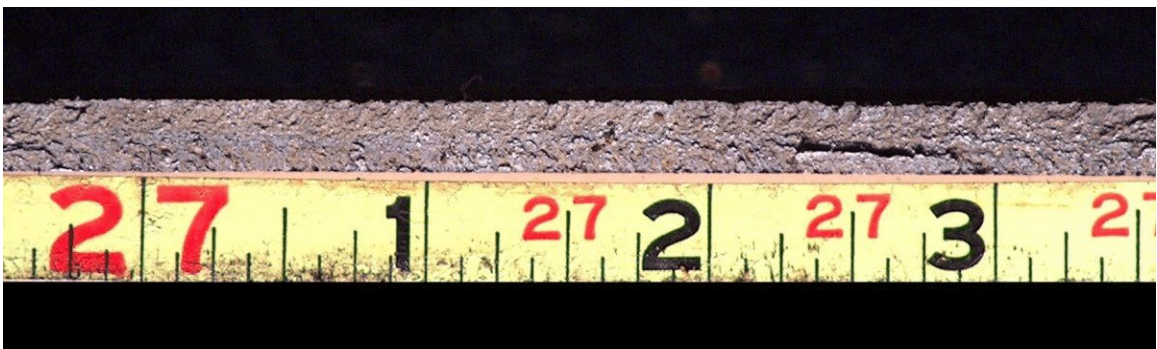
Figure 6

Close-up view of the hook crack at the reported USCD indication.

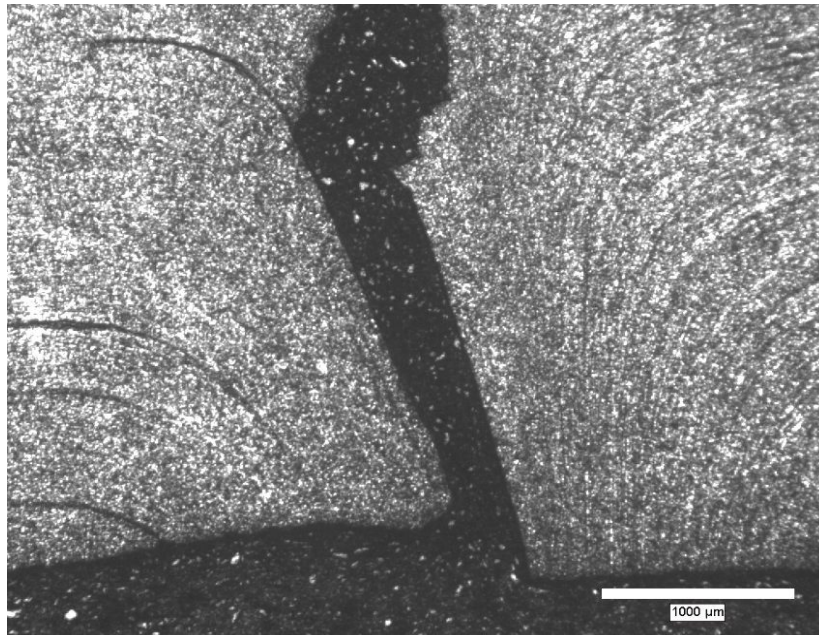
Figure 10                      Joint No. 6105                      8X  
Nital Etch

Matching transverse sections from the hook crack shown in Figure 7.

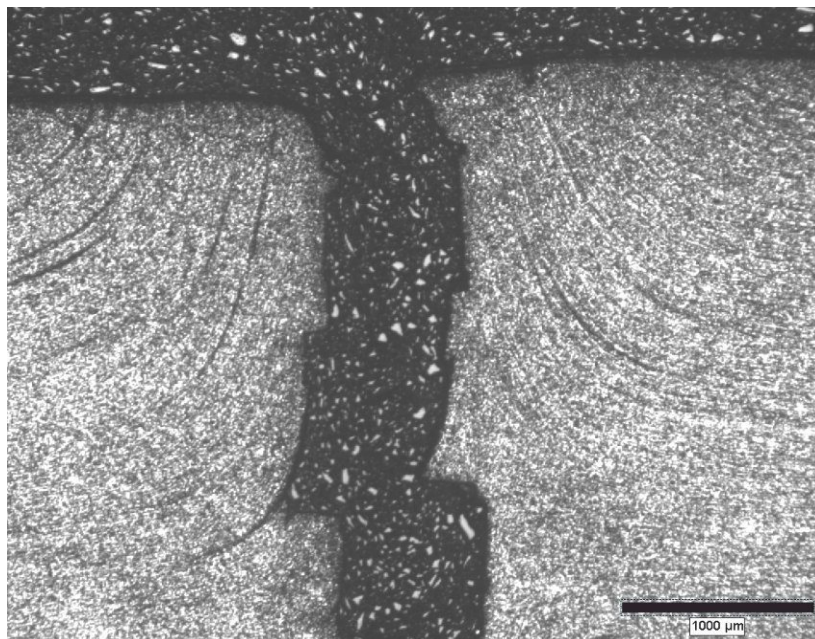
Figure 11      Joint No. 6105      25X  
Hot Picric Acid Etch

View at higher magnification at the inside surface of the section shown in Figure 8 after etching.

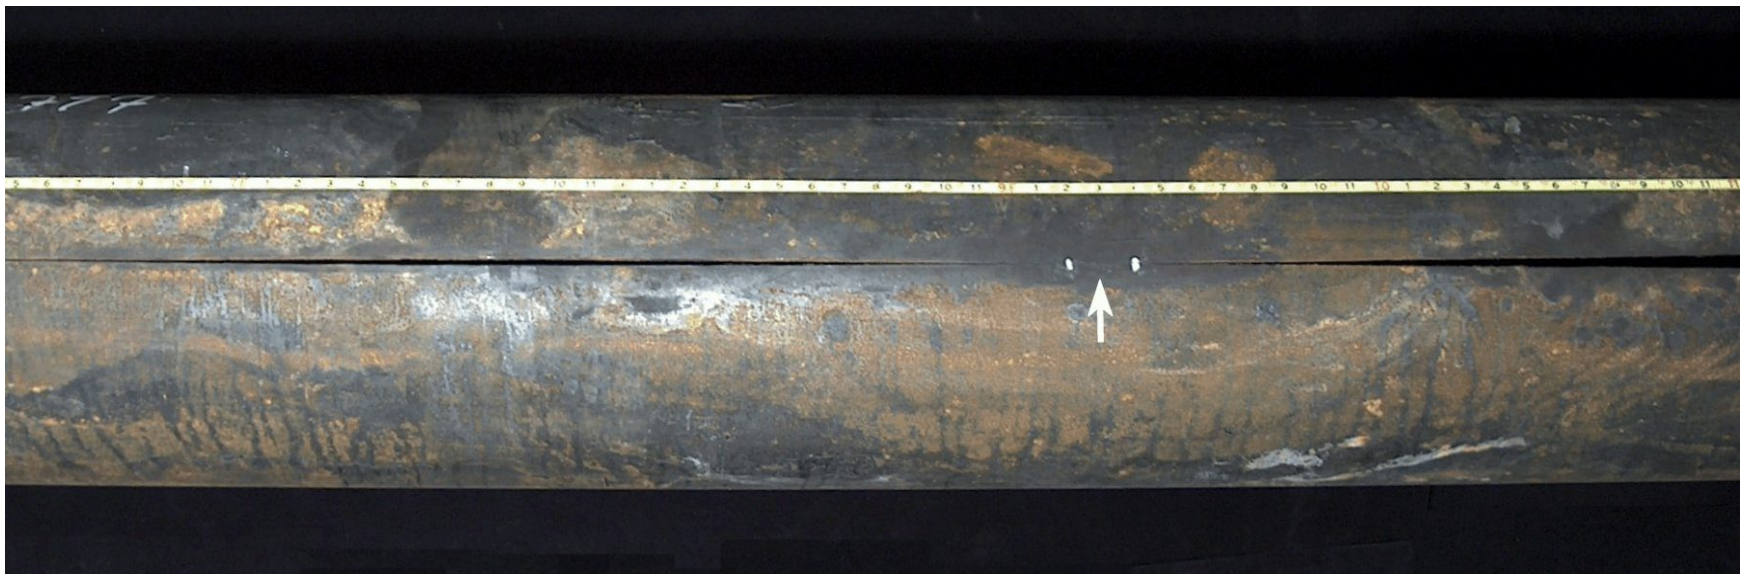
Figure 13 shows the two ruptures in Joint No. 2797, with an arrow indicating the intact area between them, shown in a closer view in Figure 14.

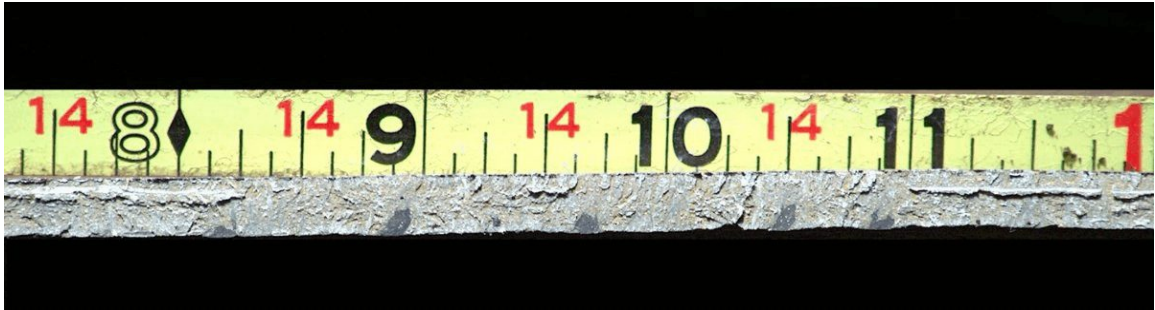
Figure 15

Photograph showing a long hook crack on the outside surface (at bottom).

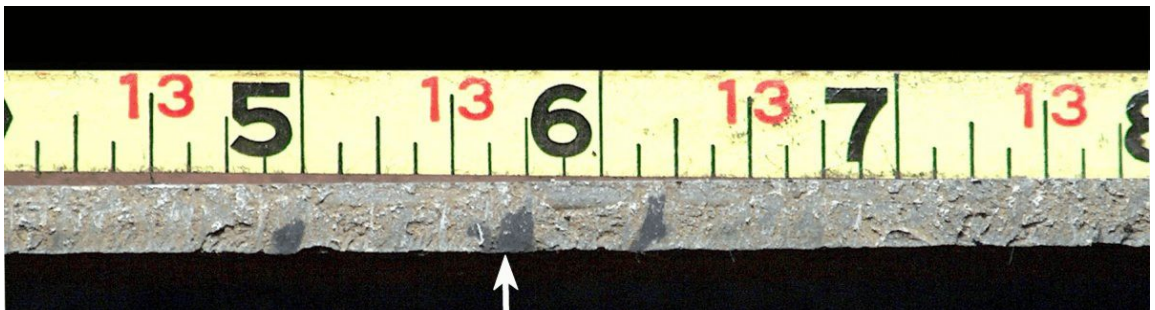
Figure 16

Photographs showing typical black spots on the outside surface (at bottom). The arrow in Figure 17 indicates the deepest flaw.

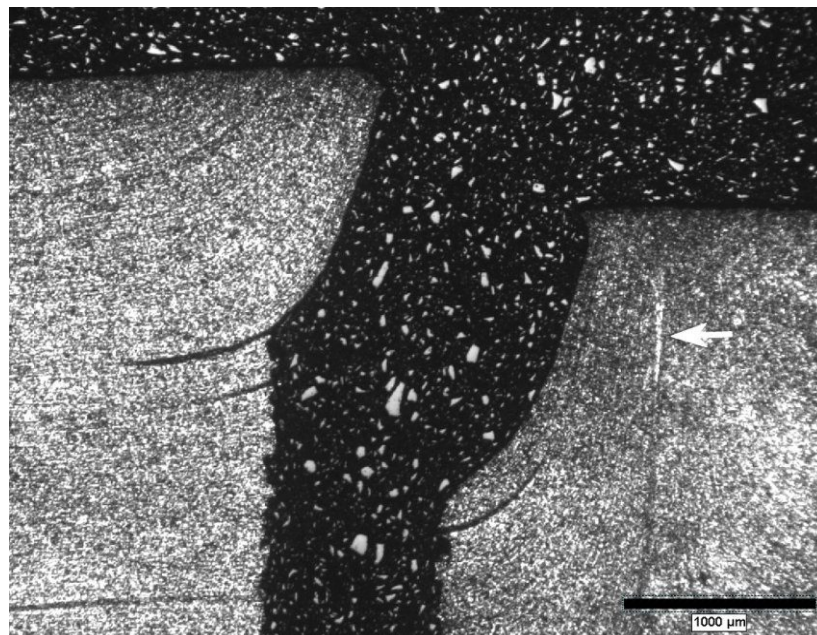
Figure 18      Joint No. 2797      8X  
Nital Etch

Matching transverse sections from the hook crack shown in Figure 15.

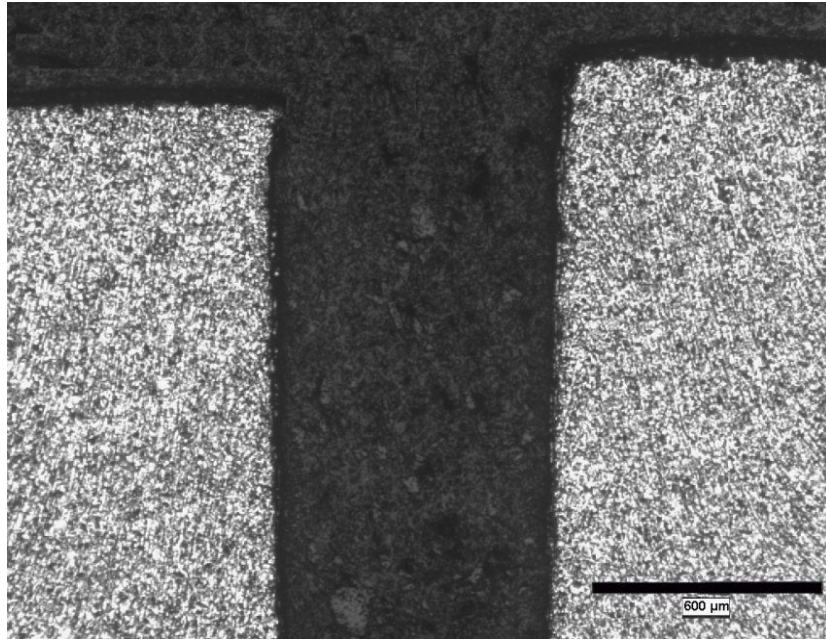
Figure 20                      Joint No. 2797                      8X  
Nital Etch

Matching transverse sections from the black spot shown in Figure 17.

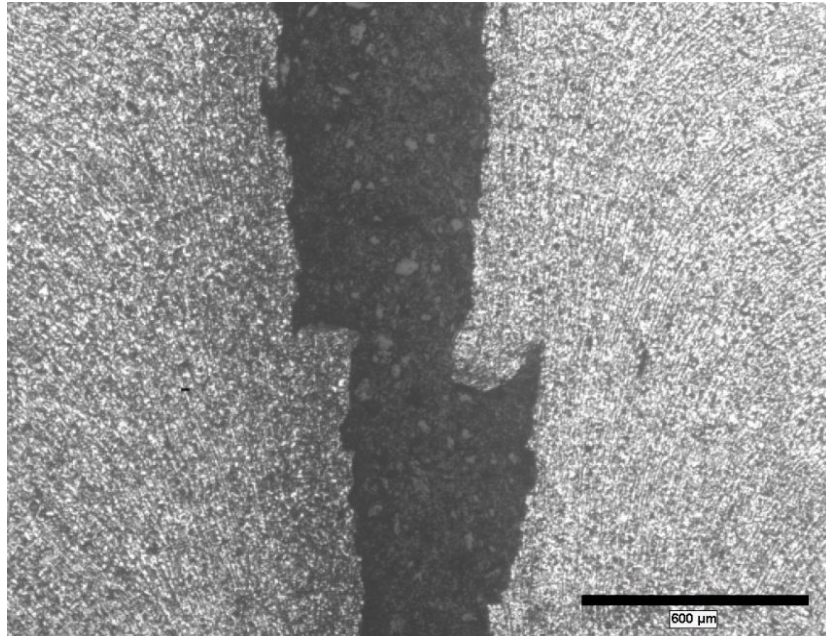
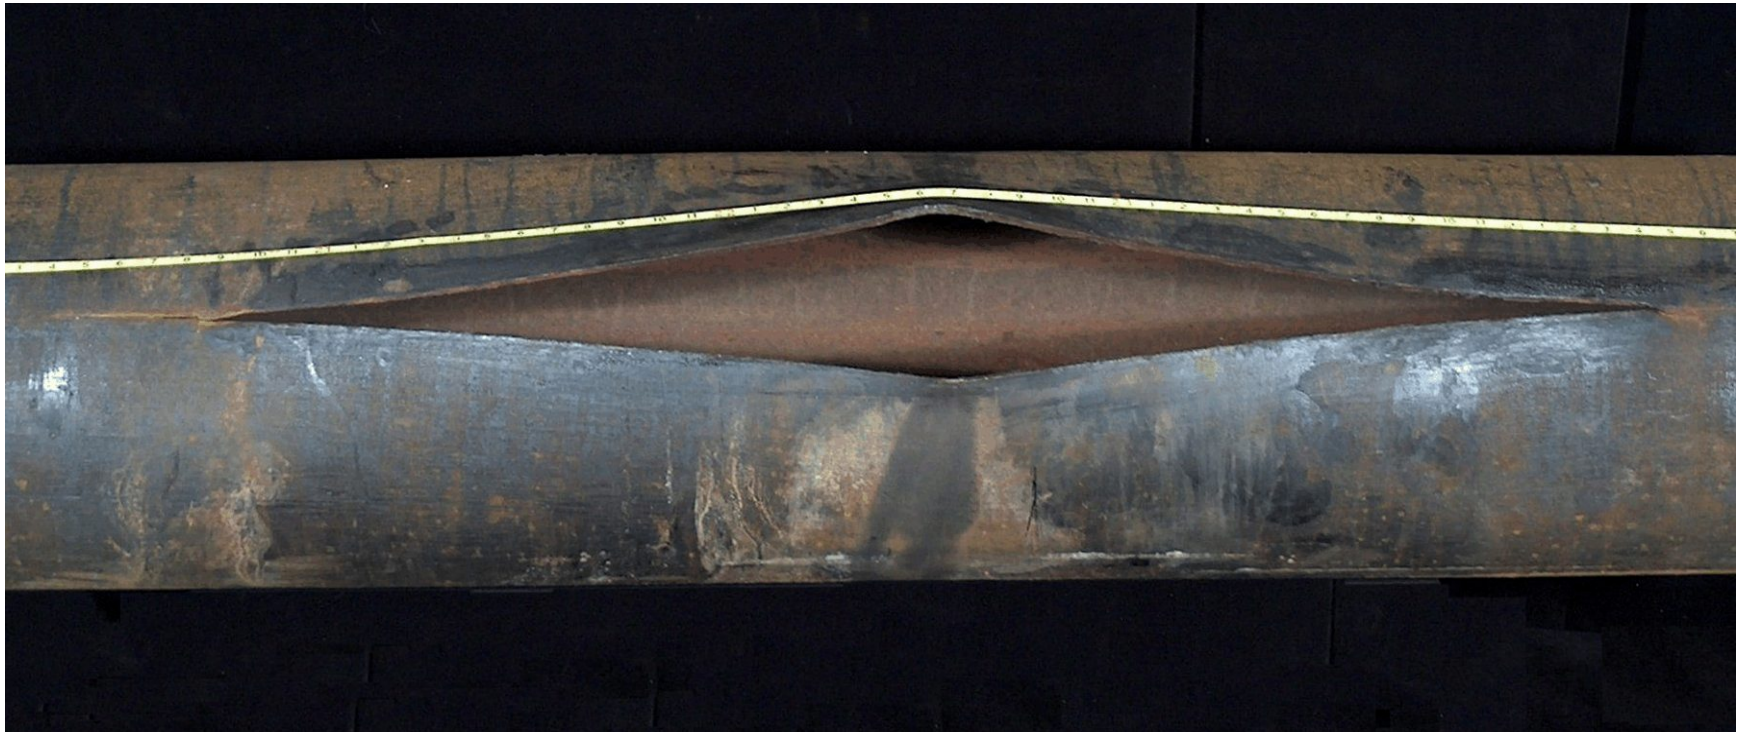
Photomicrographs showing the black spot at the outside surface, Figure 21, and near the inside surface, Figure 22.

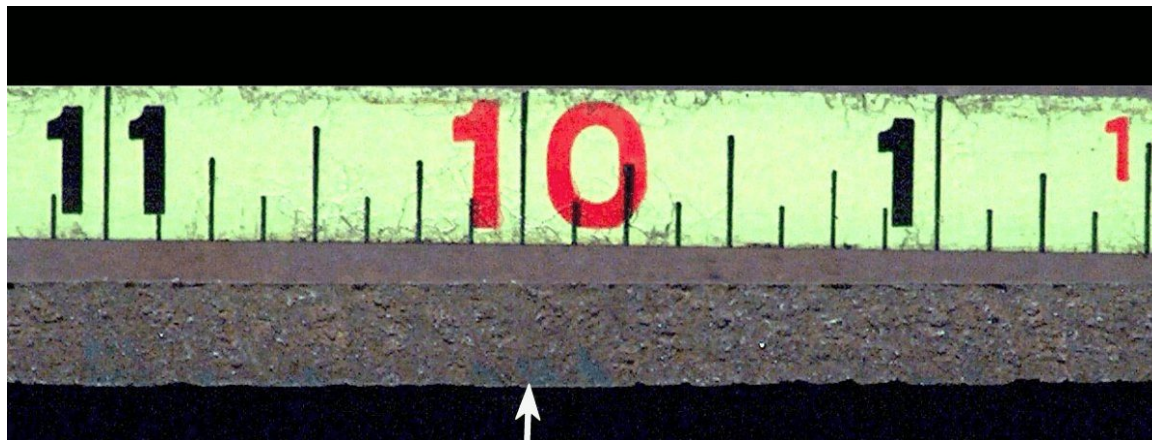
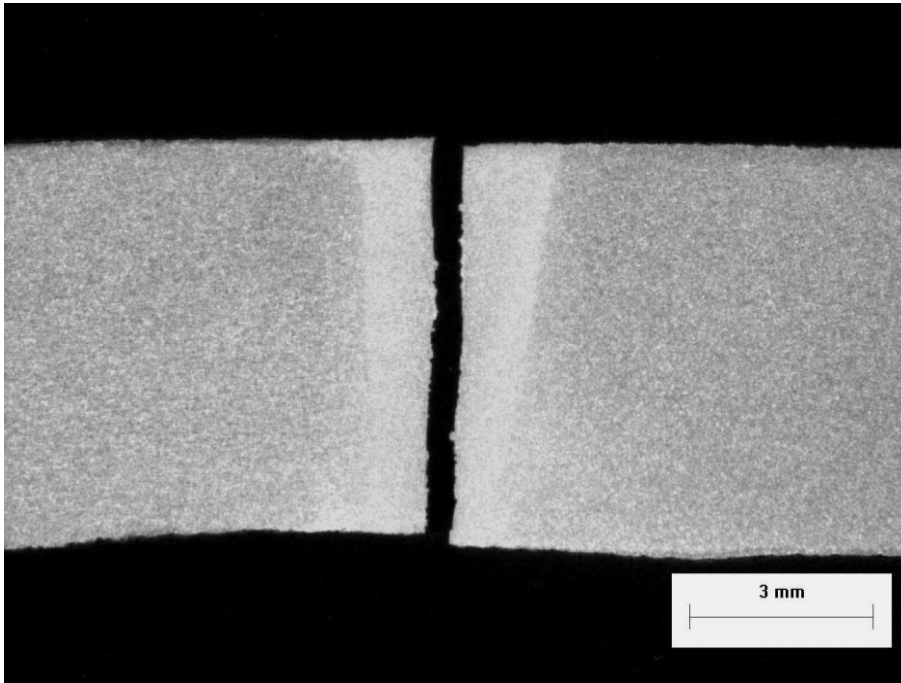
Photographs of a concentration of black spots on the outside surface, Figure 30, and of three black spots at a PAUT indication, Figure 31. The arrows indicate locations from which metallographic sections were taken.

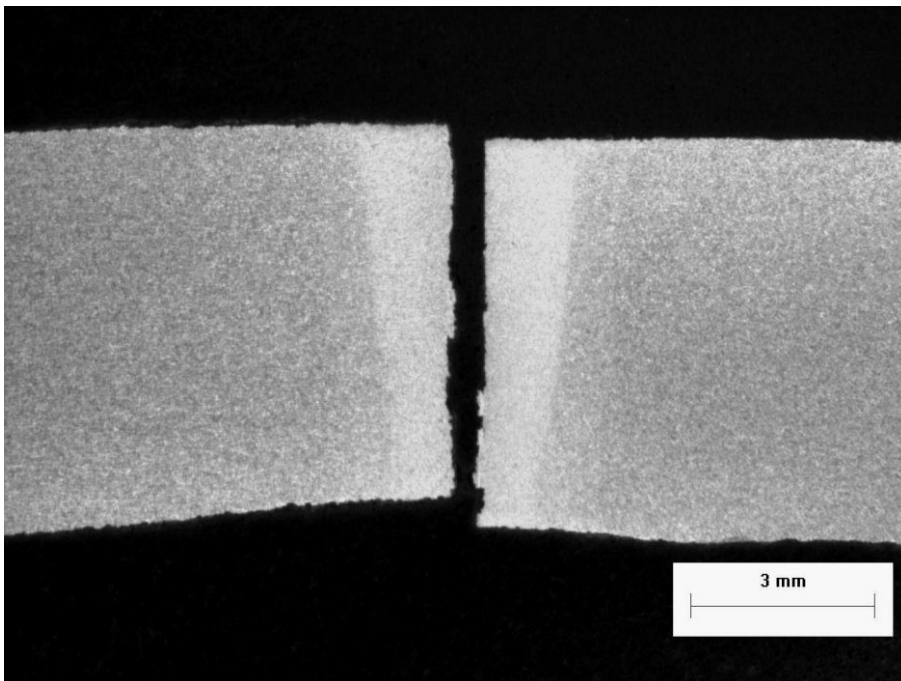
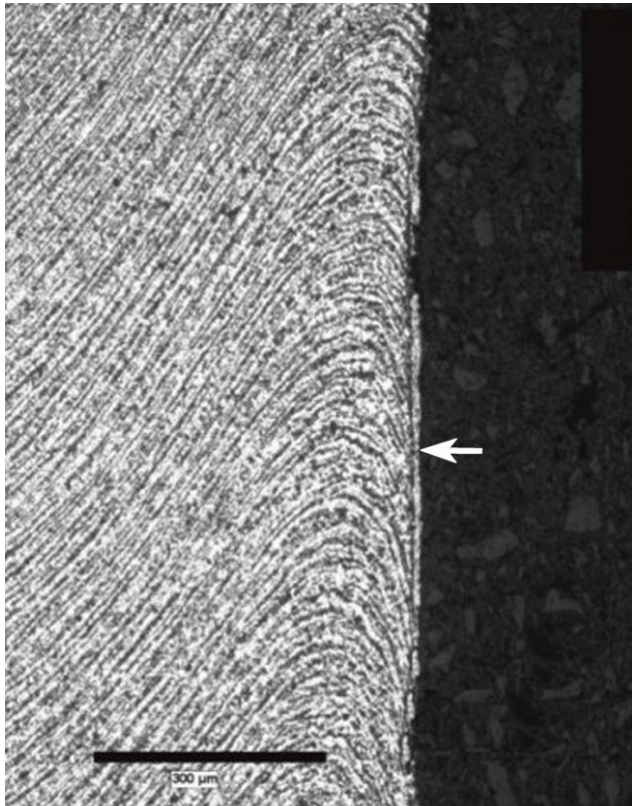
Photomicrographs showing the sections from the black spots shown in Figures 30 and 31, respectively.

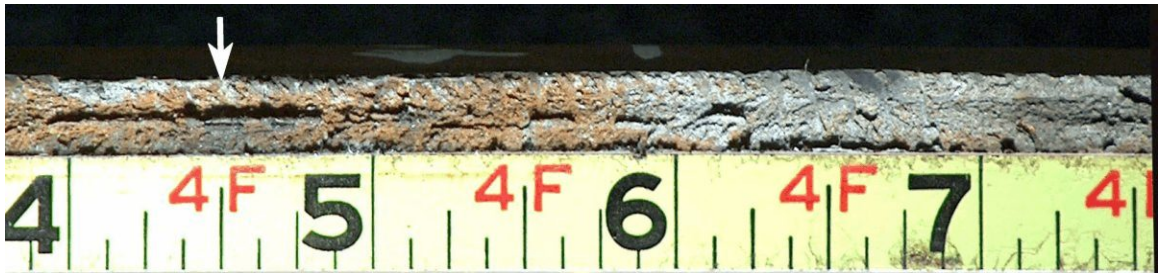
Photograph showing the fracture surface at the bulge near the middle of the rupture. The arrow indicates a location from which a metallographic section was taken.

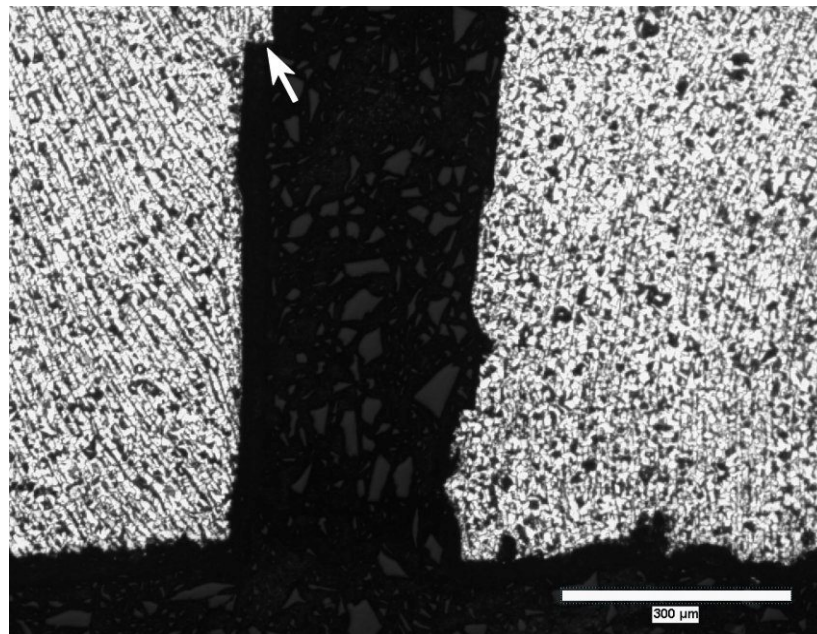
Figure 46 shows the jagged fracture just above the black spot, and Figure 47 shows the smooth fracture along the black spot, which was never fused. The arrows indicate the top of the black spot.

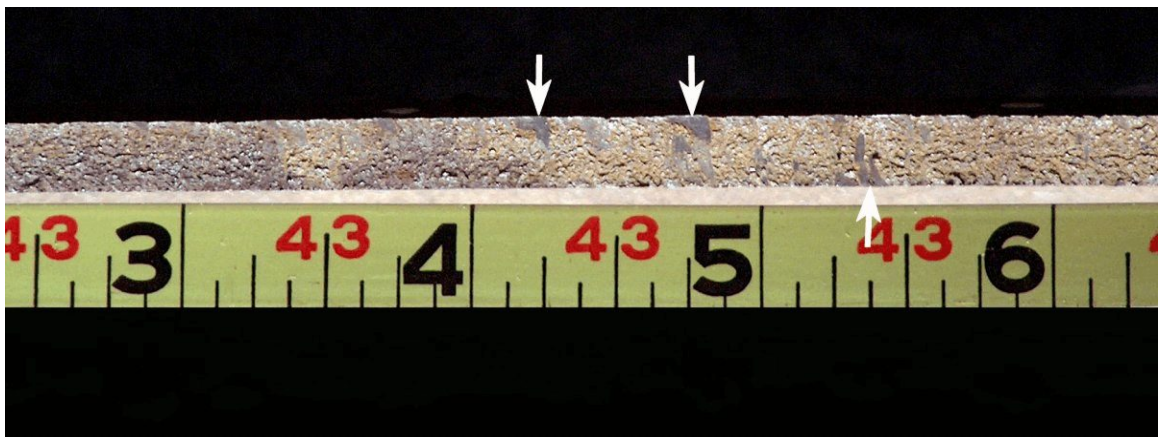
Photograph showing the rupture in Joint No. 6102.

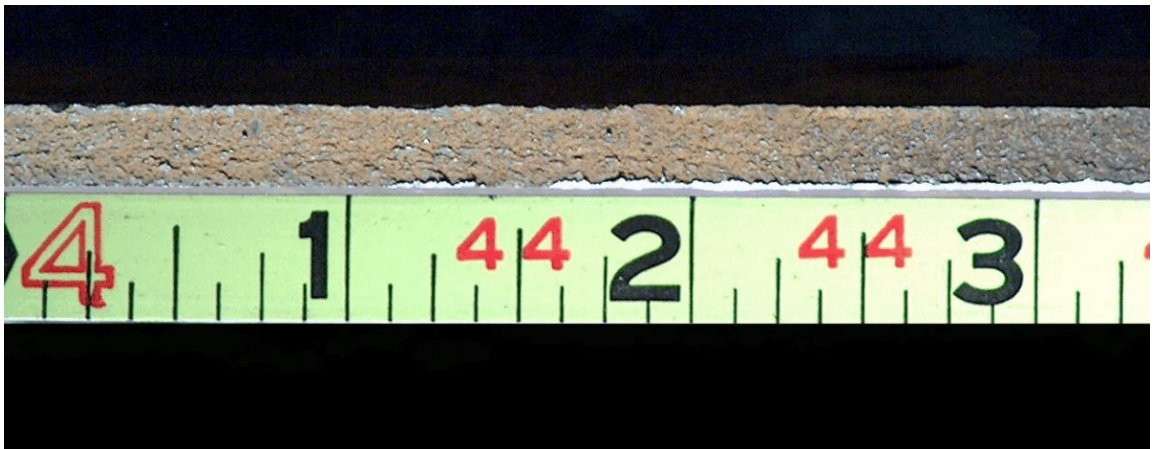
Matching transverse sections were taken from the black spot at the 43 feet, 5 inch mark in Figure 49, and across the hook crack near the 44 feet, 2 inch mark in Figure 51. Figures 52 and 53 show the sections after polishing and etching. Note the heat-affected zones that show this joint either was not manufactured by Lone Star Steel, or was not full-body normalized after welding. The fracture along the black spot was straight and flat, as shown in Figure 54. Note that the fibers on each side of the fracture are reverse bent so that they turn back down at the weld instead of turning toward the outside surface. A thin layer of scale can be seen on the fracture at left, and a thin layer of decarburized (light-etching) metal can be seen on the fracture at right.

Photographs showing the fracture surface at the two reported USCD indications.

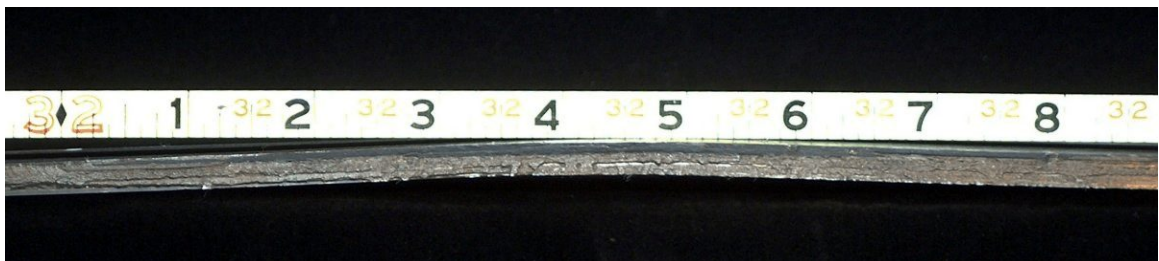
The rupture in Joint No. 2753, shown in Figure 55 was 10 feet, 9 inches long and opened less than an inch at the widest point. The fracture surfaces were rough and irregular for most of the length, with long hook cracks apparent at several locations. The most likely failure origin was at a long hook crack at the outside surface near the middle of the rupture where a 4.9-inch long USCD indication was reported. Figure 56 shows the hook crack that extended approximately from 32 feet to 32 feet, 8 inches; the USCD indication was reported at 32 feet, 4 inches

Photograph showing the rupture in Joint No. 2753.

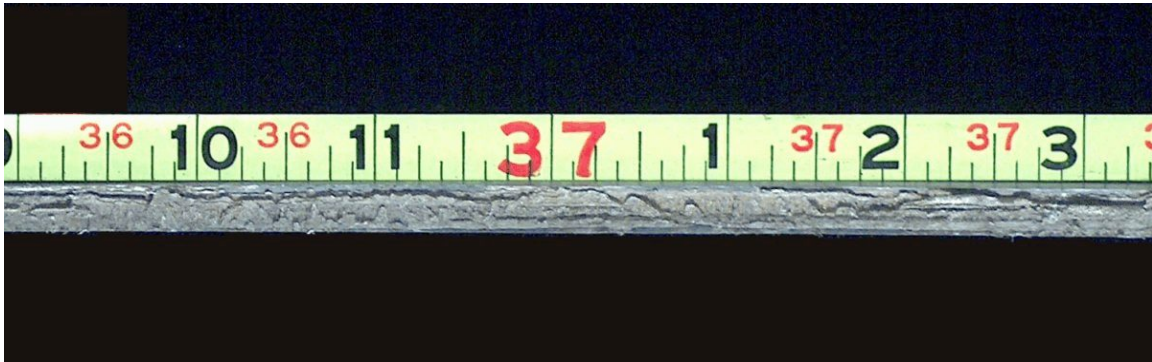
(32.32 feet). The depth of the flaw at the origin was 59 percent of the wall thickness. Figures 57 and 58 show another representative location.

Figure 57 shows a typical location with hook cracks and multilayer fracture surface, and Figure 58 is a closer view of part of the fracture.

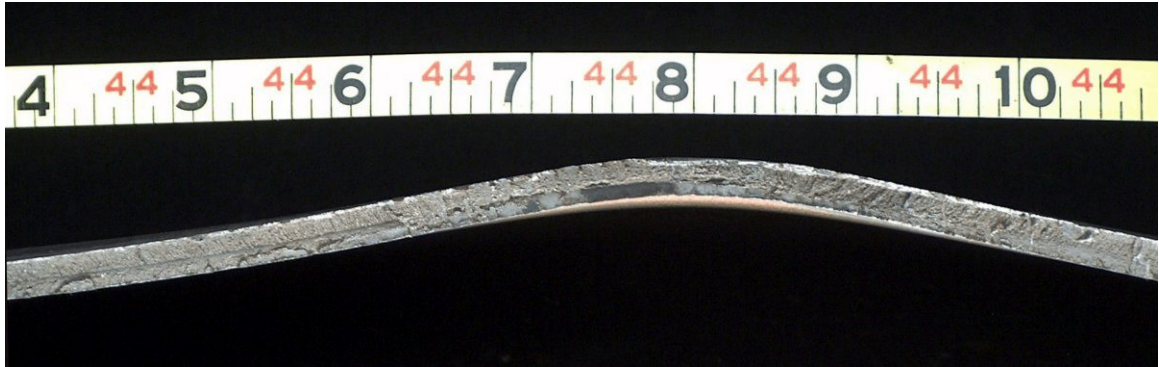
Joint No. 4013, shown in Figure 60, ruptured for a length of 4 feet, 11 inches. The apparent origin was at a hook crack located at a bulge near the middle of the rupture, centered at 44 feet, 8 inches, as shown in Figure 61. The depth of the hook crack was 44 percent of the wall thickness. The rest of the fracture was mostly flat and brittle, with apparent flaws on the inside surface at a few locations. A USCD indication was reported at 45 feet, 7 inches (45.6 feet). As shown in Figure 62, there appeared to be a large hook crack or other flaw at the inside surface at that location.

Photograph of the rupture in Joint No. 4013.

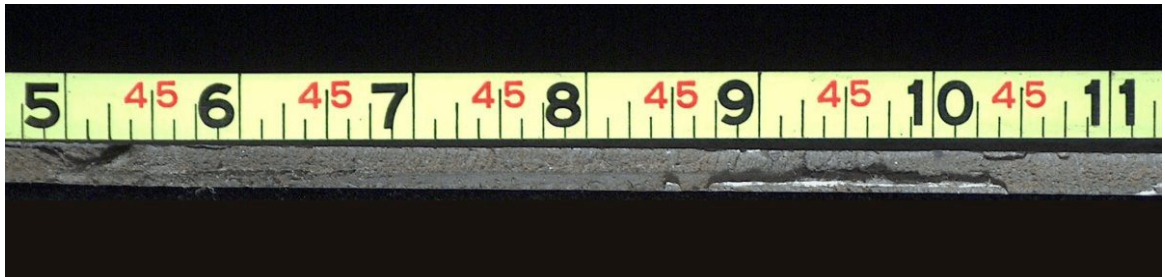
Matching transverse sections were taken from the middle of the area shown in Figure 61, and are shown in Figure 63 after polishing and etching. The flaw at the inside surface was adjacent to the weld line, and examination at higher magnification showed that it was along the down-turned fiber lines, hence was a hook crack

Figure 61 shows a hook crack on the inside surface at the failure origin, and Figure 62 shows the fracture at the location of a reported USCD indication (45 feet, 7 inches).

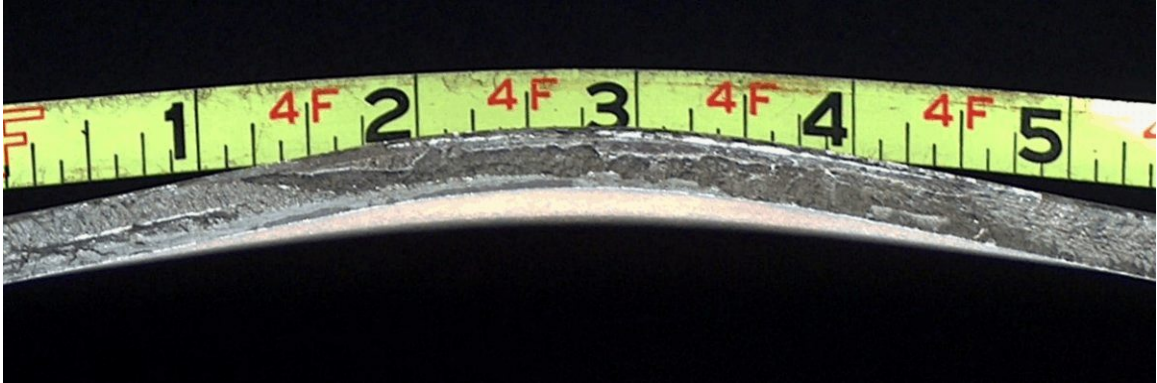
Joint No. 6418, shown in Figure 64 ruptured near one end of the joint, for a length of 4 feet, 8 inches. The apparent fracture origin was at a bulge at 4 feet, 3 inches, shown in Figure 65. There appeared to be flaws at both the inside and outside surfaces, the combined depths of which were approximately 60 percent of the wall thickness. There were no inspection indications reported in the fracture length. The rest of the fracture was mostly flat and brittle, with hook cracks apparent at a few locations. Figure 66 shows a location with a long hook crack near midwall.

Photograph showing the rupture in Joint No. 6418.

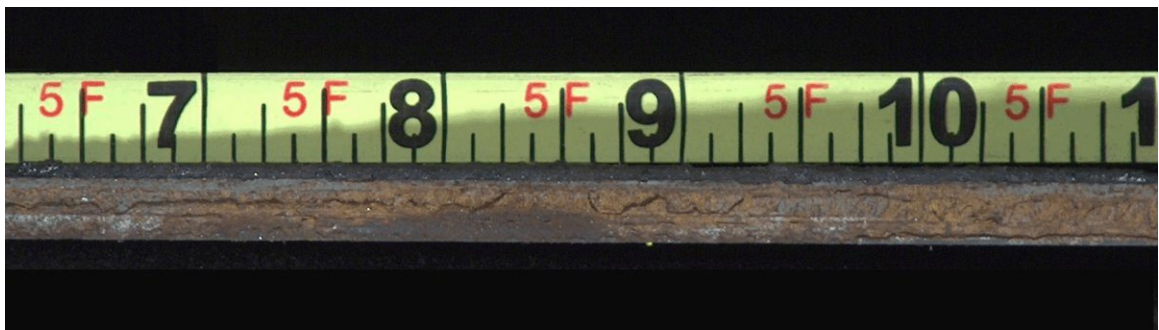
Joint No. 10737 been wrapped with Polyguard and a strip of the coating had to be removed to examine the rupture. Figure 68 shows the pipe after the strip was removed from each side of the rupture, which was 8 feet, 1 inch long. The fracture surface contained a large number of hook cracks along the length of the rupture, with brittle fractures in between. The failure origin was not apparent but likely was at one of the hook cracks. Manual and PAUT inspection indications were reported at 5 feet, 6 feet, 5 inches (6.4 feet), 6 feet, 7 inches (6.6 feet) and 8 feet. The indication at 5 feet was reported to be 10.93 inches long and 36 percent of the wall thickness deep. Our examination showed the deepest flaw, 50 percent of the wall thickness, to be at 5 feet, 8.5 inches, shown in Figure 69. The fractures at the other two reported indications contained large hook cracks, as shown in Figures 70 and 71.

Photograph showing the rupture in Joint 10737.

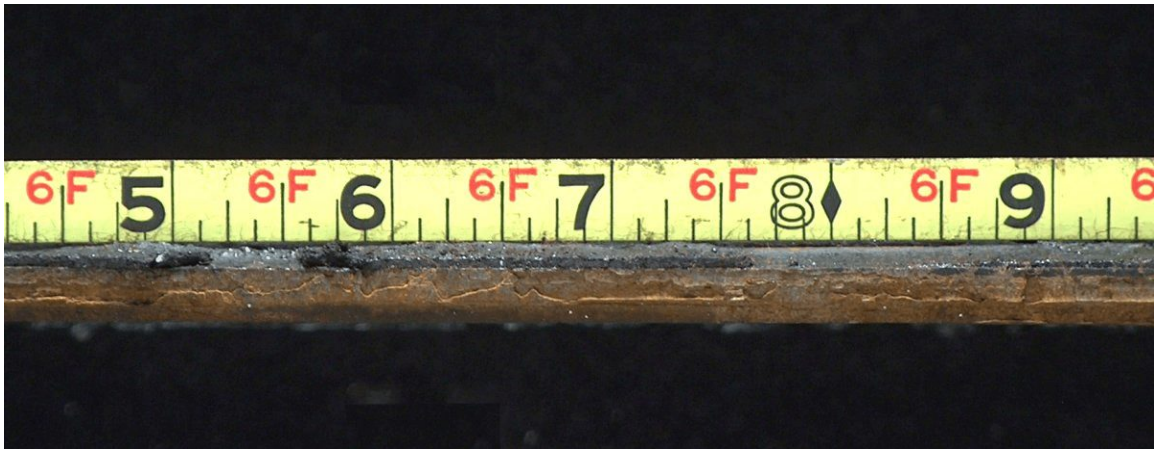
Figure 69

Photograph of the fracture at the deepest flaw, which was in the middle of a long USCD reported indication.

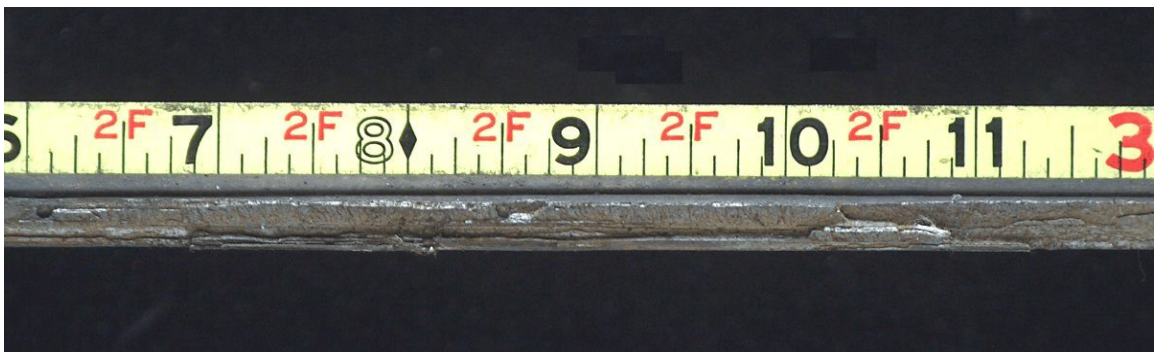
Figure 70

Photographs showing hook cracks on the fracture surface at the other two reported USCD indications.

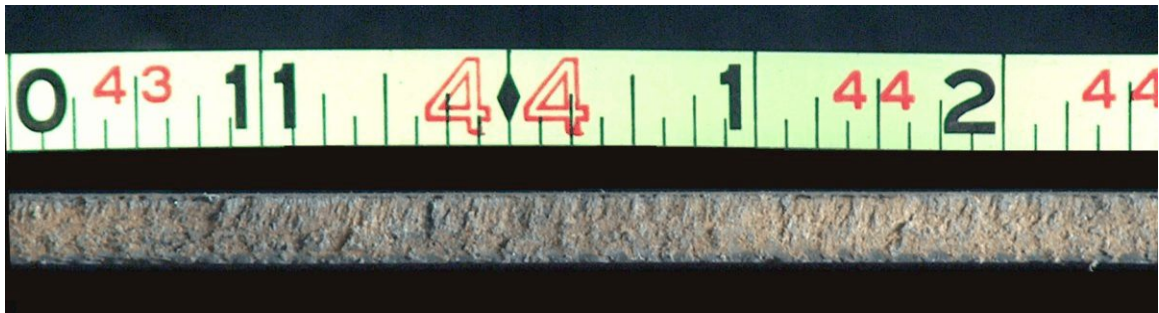
Figure 74

Photograph showing the fracture at the failure origin.

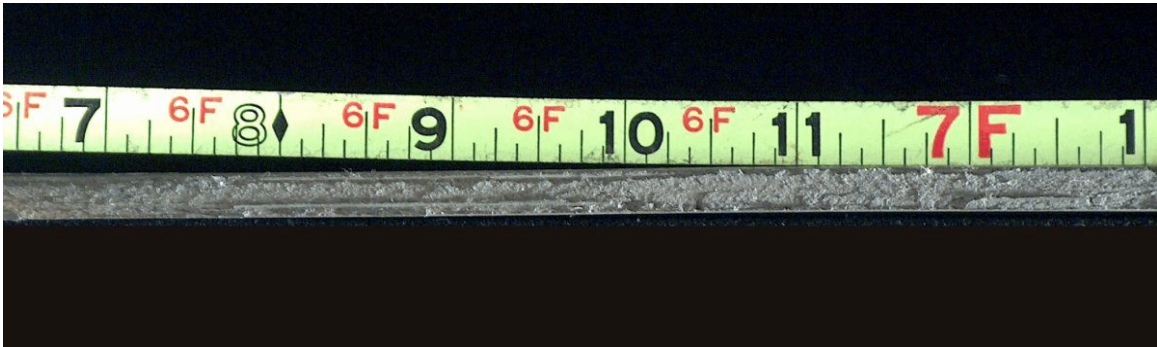
Figure 78 shows the fracture at the failure origin, and Figure 79 shows a typical area of brittle fracture and hook cracks.

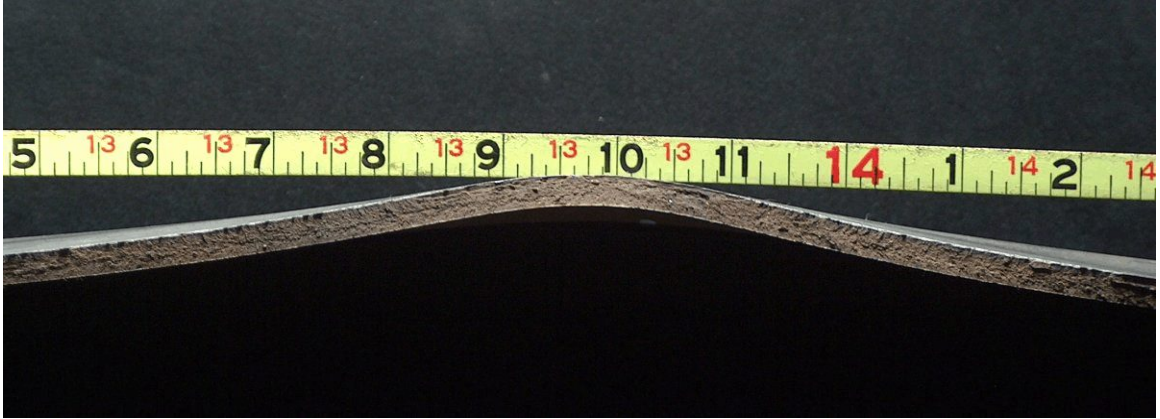
Photograph showing the rupture in Joint No. 332.

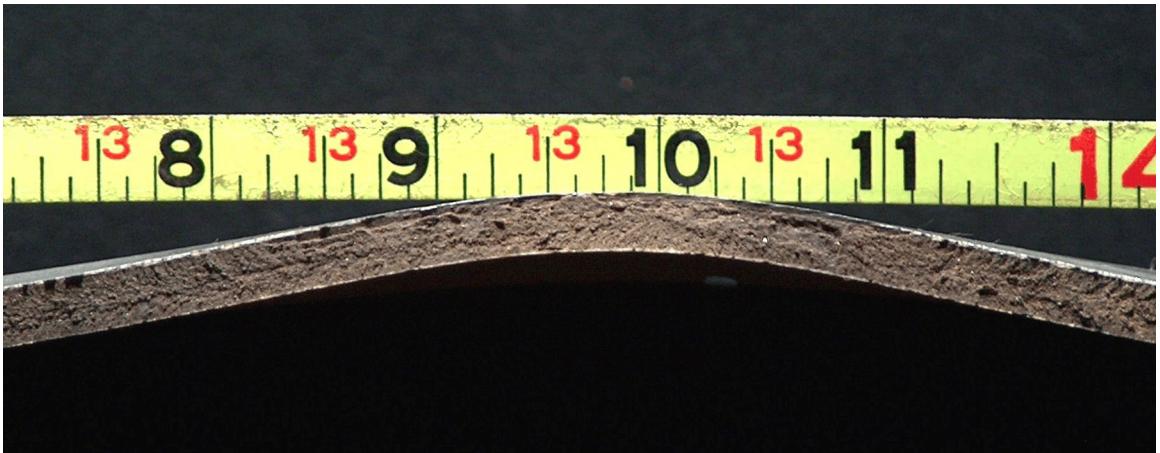
Figure 89 shows chevrons pointing toward the failure origin, and Figure 90 is a closer view of the origin.

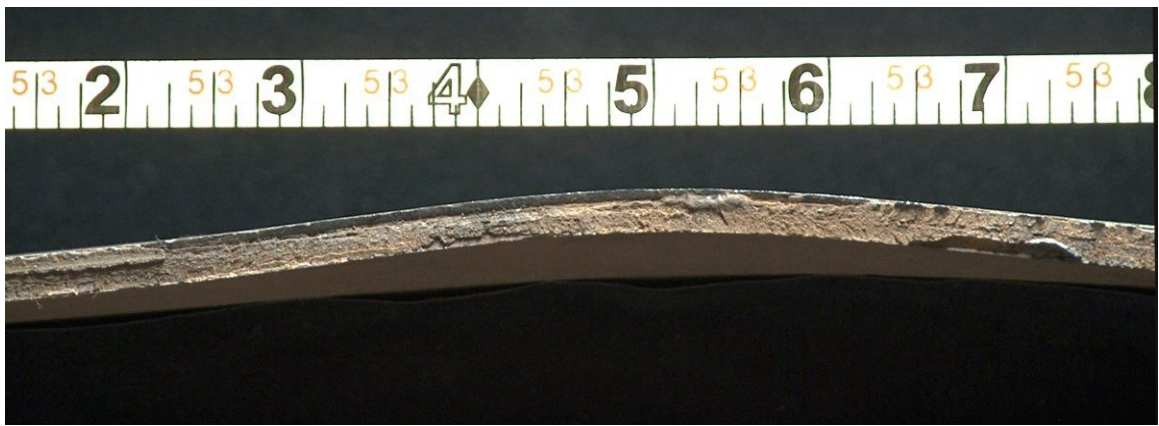
Photograph showing the rupture in Joint No. 6005.

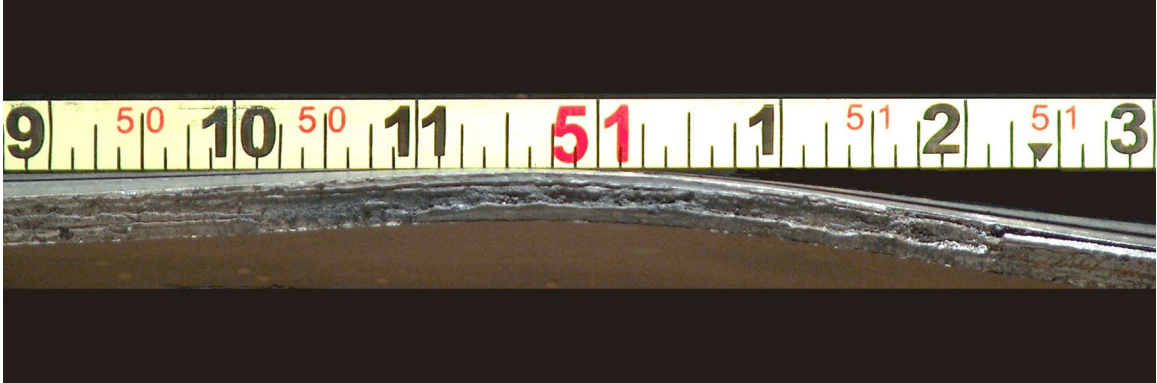
Photograph showing the rupture in Joint No. 2405.

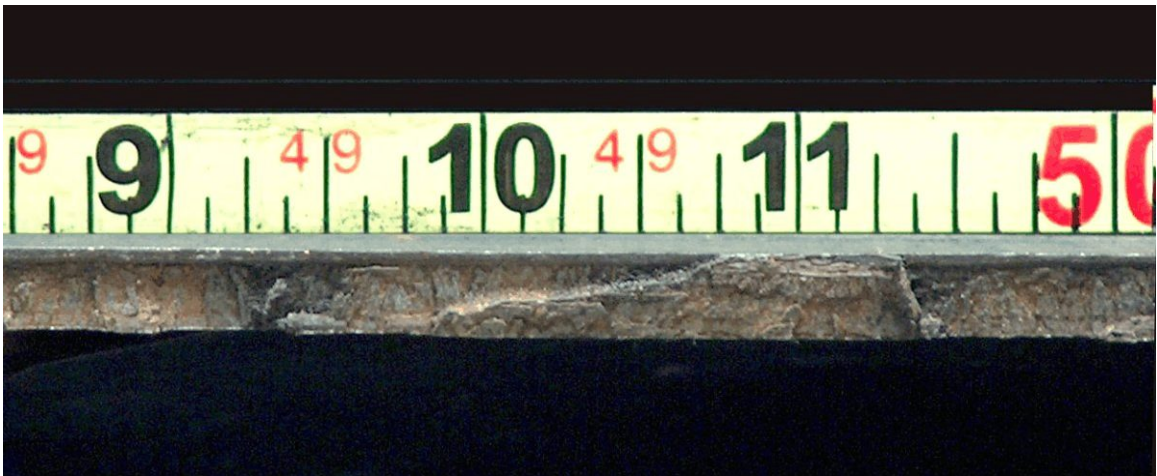
Figure 99 shows the deepest flaw and likely failure origin, and Figure 100 shows part of a hook crack within the length of a reported USCD indication.

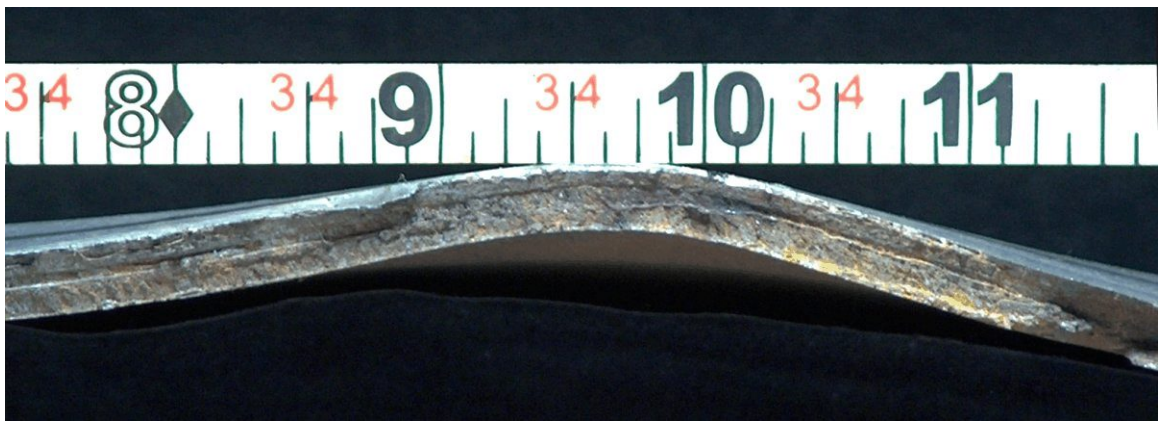
Photograph showing the rupture in Joint No. 386.

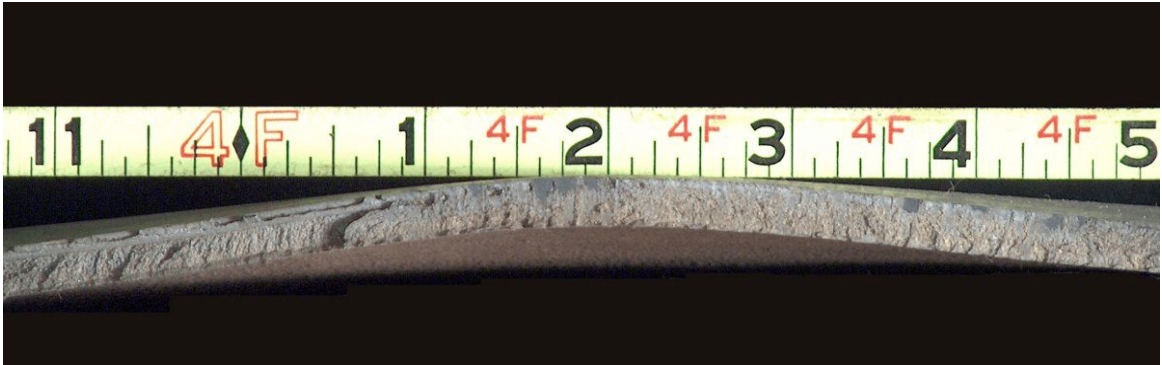
Photograph showing the rupture in Joint No. 8769.

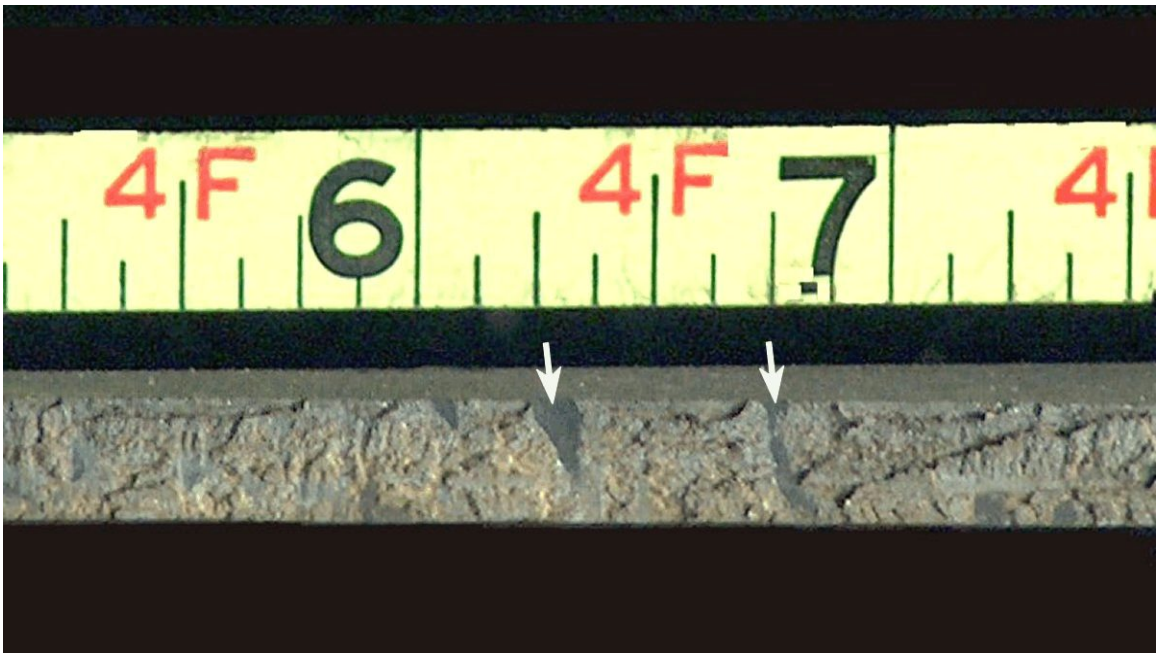
Figure 106 shows a hook crack, multilayered fracture and black spots at a bulge near the center of the rupture, and Figure 107 shows the deepest flaws, arrows, found along the rupture.

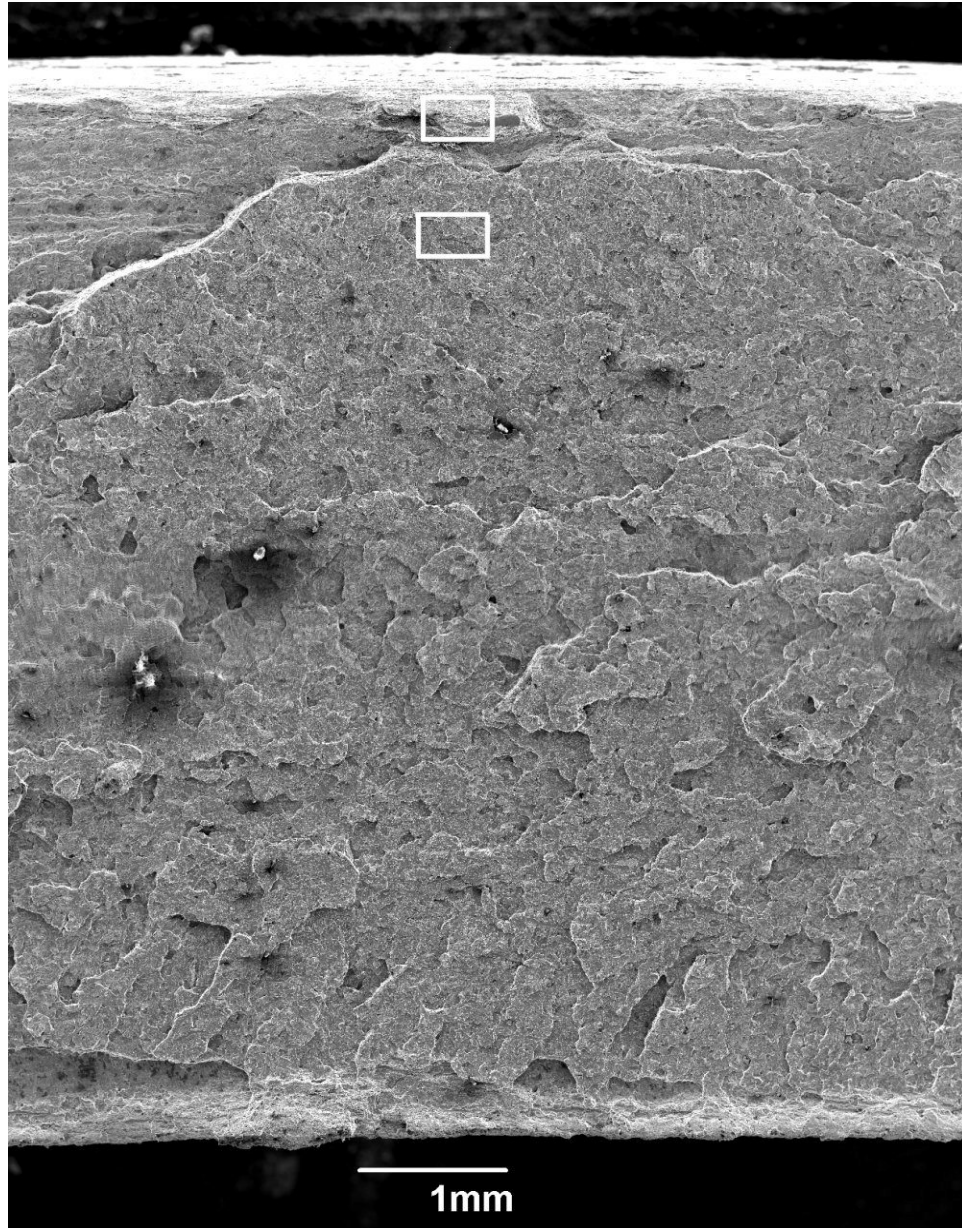
Figure 108                      Joint No. 8769                      8X  
Nital Etch

Matching transverse sections from the black spots indicated by the arrow at left in Figure 107.
